# TOWN OF ALBERTON

## WATER SYSTEM IMPROVEMENTS PROJECT 2020

### PRELIMINARY ENGINEERING REPORT

May 2020

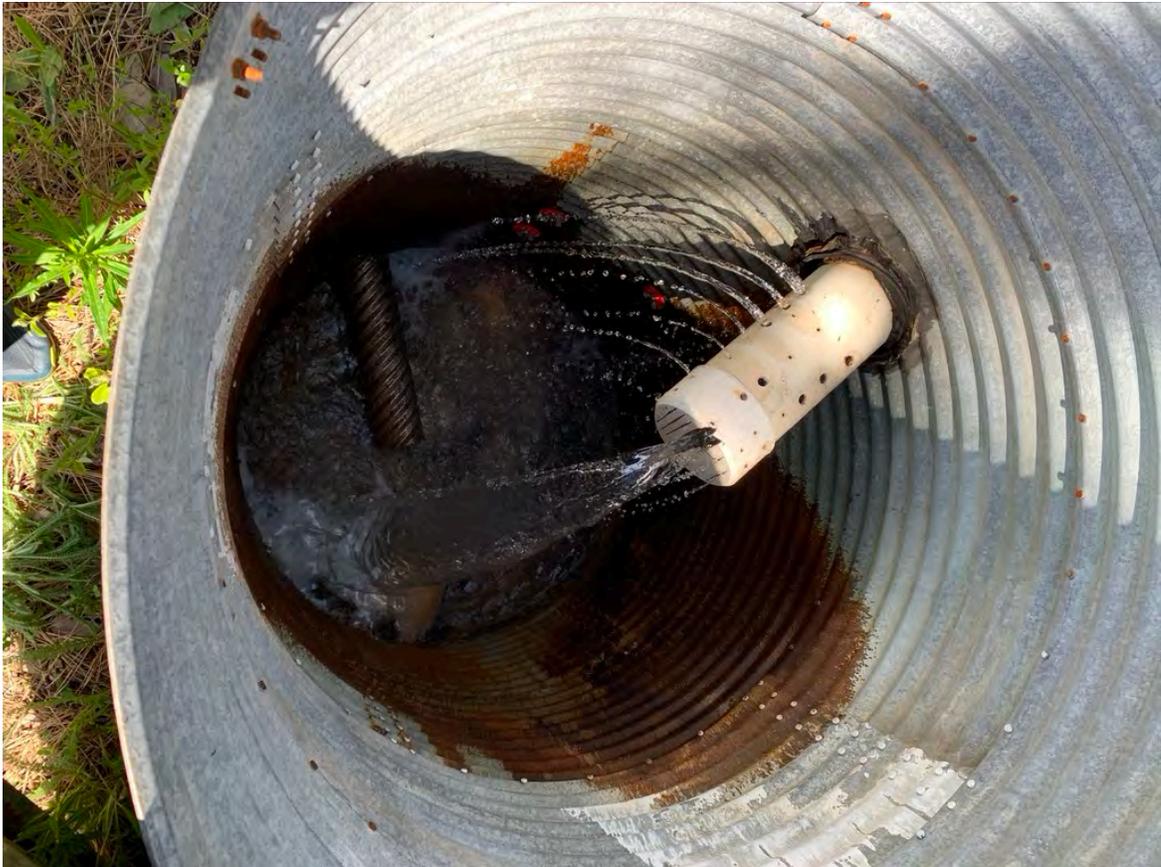
Spring collection structure (with normally sealed cover removed) 5 May 2020

The design drawings of the spring collection system do not provide any records on the construction or the materials that were used to assemble the system. Some of the materials used during construction are believed to be some combination of cast iron, concrete, and corrugated metal pipe, based on the visible pipe ends inside of the three metal manholes. Several of the pipe ends in the collection manholes are showing signs of deterioration. All three collection manholes are fitted and covered with lockable metal covers, however, the lids do not have a rubber seal.

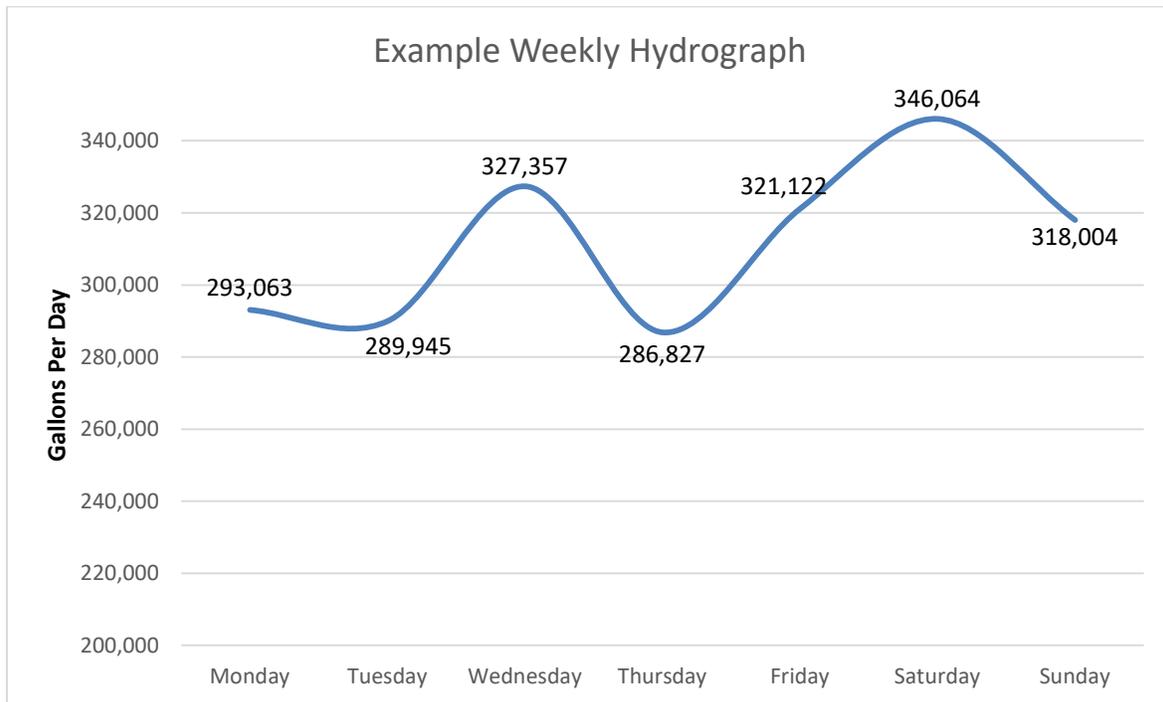
In the example shown, the weekly total gallons used equals the average summer daily demand for Alberton multiplied by seven days. However, because the demand is not a straight line the actual maximum day is higher than the average summer daily demand.

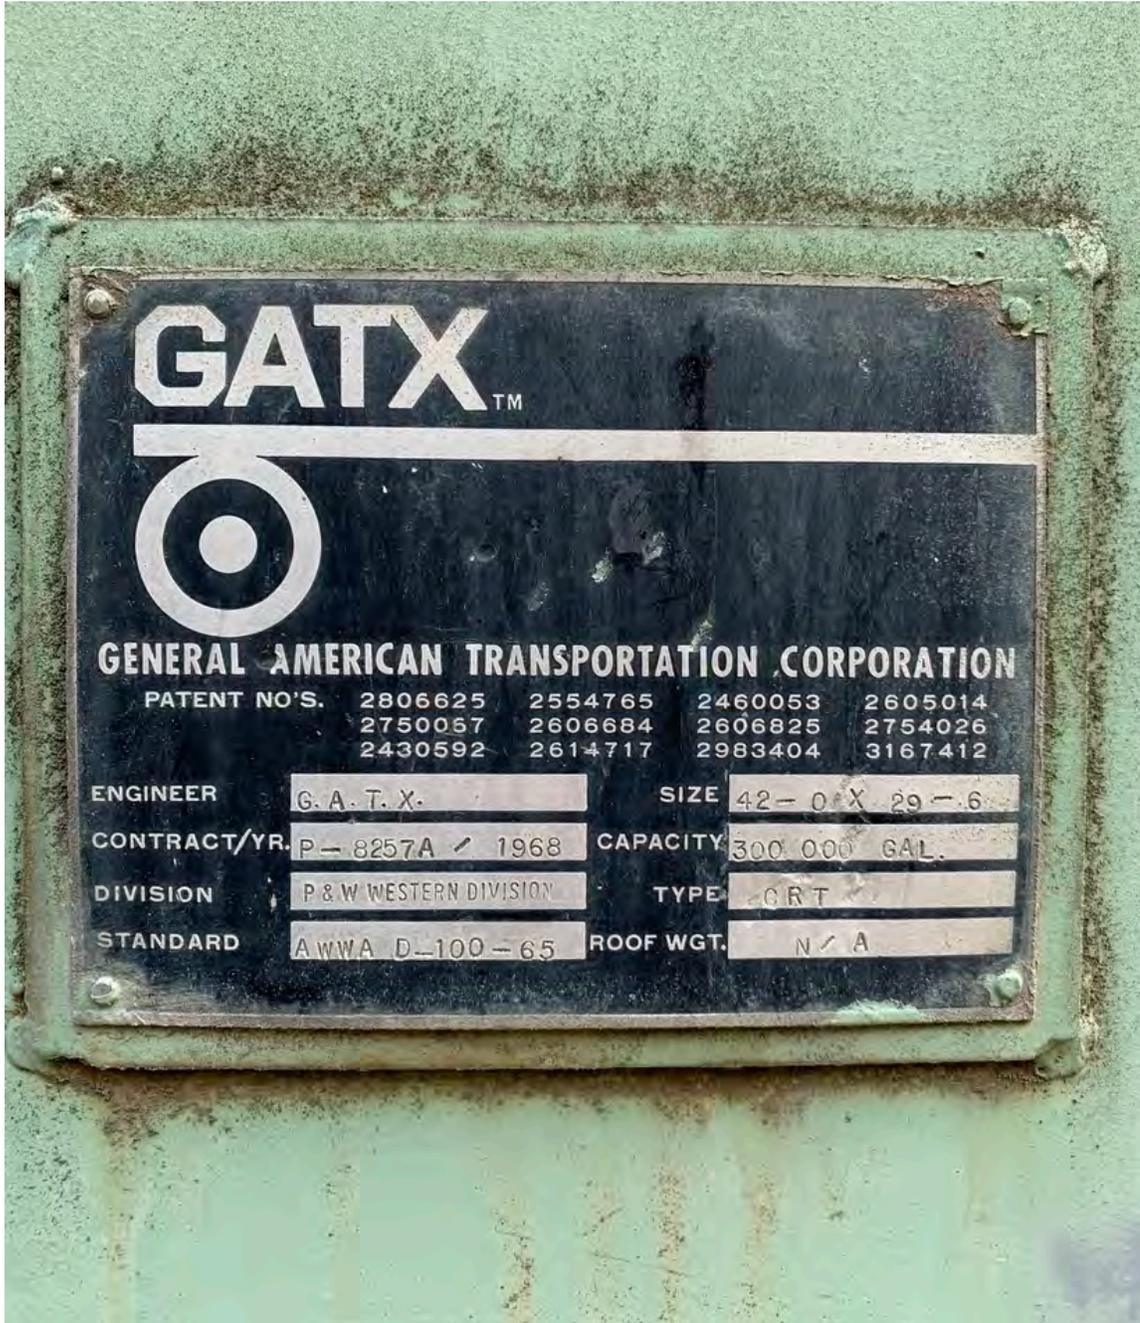
Alberton is currently using a 300,000-gallon steel water storage tank. The steel tank has a 42-foot diameter and stands 30 feet tall. Construction of the tank was completed in 1968.

The tank is a welded steel construction with a concrete ring wall foundation and a steel floor sheet. There is an un-caged steel ladder on the north side of the tank. Currently there

are no roof railings or walkways around the access hatch and current safety standards require fall prevention equipment and railings. Nominally the tank is considered to have a capacity of 300,000 gallons but the actual capacity to overflow the tank is approximately 301,000 gallons. The tank typically operates in overflow condition.

The tank is equipped with a dedicated overflow pipe on the interior wall and daylights near the roof knuckle at an invert elevation 29.0 feet above the tank floor. The overflow pipe is typically used most of the year due to the absence of a control system and the failure of a flow control valve (stuck in the open position), that would divert excess flow prior to the tank if functioning.

In September of 1997 the interior of the tank was evaluated by Liquid Engineering. The evaluation was completed by diver-inspection. Liquid Engineering rated the interior of the tank “good” to “excellent” with few areas showing corrosion. The areas of corrosion were noted to be on the welded seams and coating “holidays” (pinholes). There was approximately a ½” of accumulated silt on the floor of the tank. The exterior coating on the tank is showing signs of deterioration and needs to be prepped, primed and repainted.

The tank was again inspected by Independent Inspection Service of Helena in May of 2019 (see report in **Appendix D**) by remote operated vehicle (ROV). The tank was assessed to be in overall satisfactory condition with the main recommendations being to clean sediment from the interior of the tank, install a new screen on the vent and have it inspected again in 3-5 years.

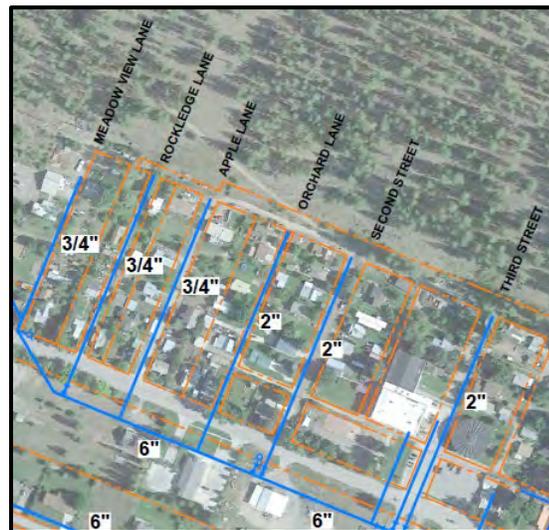
In addition, the dead-end mains and lack of looping prevent efficient delivery of water during high demands such as fire flows or other high demand uses. This is especially true where the dead-end mains occur on already undersized mains which would be inadequate even if they were looped, see snip below. The mains need to be replaced with larger mains and looped where appropriate.

As previously mentioned, residents north of Railroad Avenue, along Adams Street, and Parkway drive are all served by dead end mains. The un-looped dead end mains can collect sediment and allow water to become stagnant. This has the potential to create water quality issues. Circular DEQ-1 requires all dead end mains to have a flushing hydrant, (not available in Alberton). Flushing hydrants would allow the Town to maintain the dead end lines, but do require regular flushing in order to eliminate stagnant water. Circular DEQ-1 recommends looping all dead end mains whenever possible.

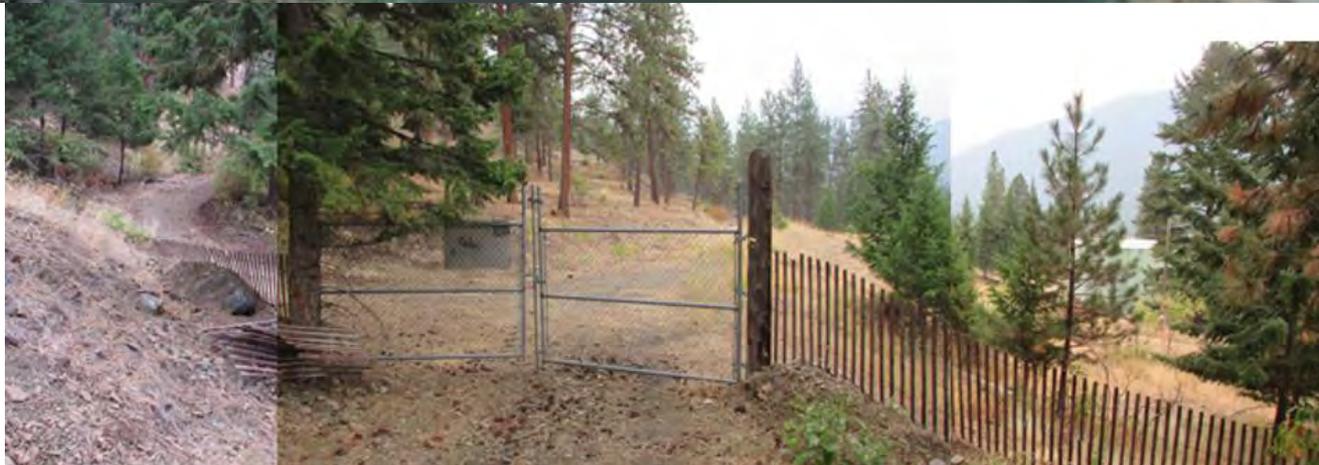
Gate and fencing erected  
across access road to springs  
area to deter public access.

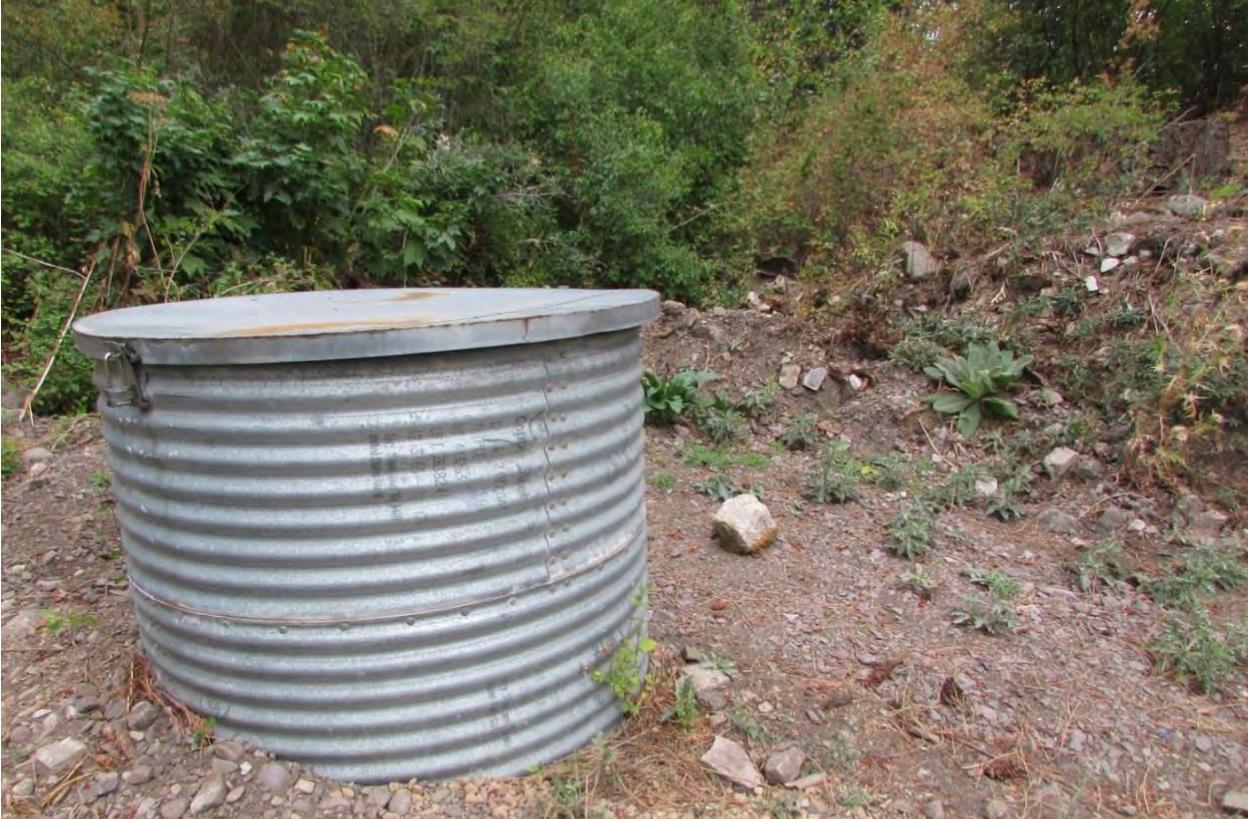
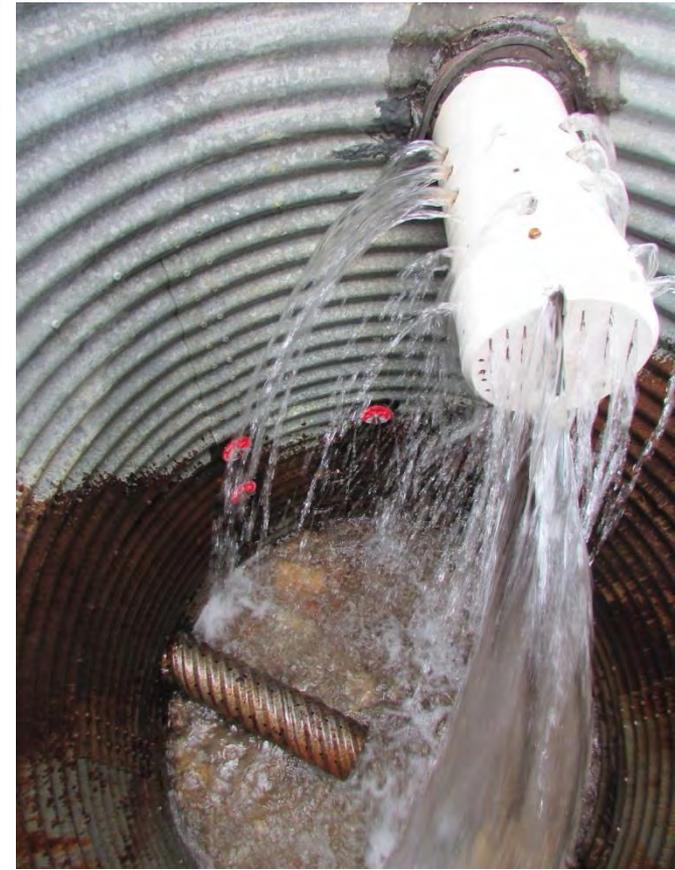
SP002 showing the lower (main) spring box with new gasket, padlock and hasp (lower left photos) and diffusion cap for main supply lateral (lower right photo).

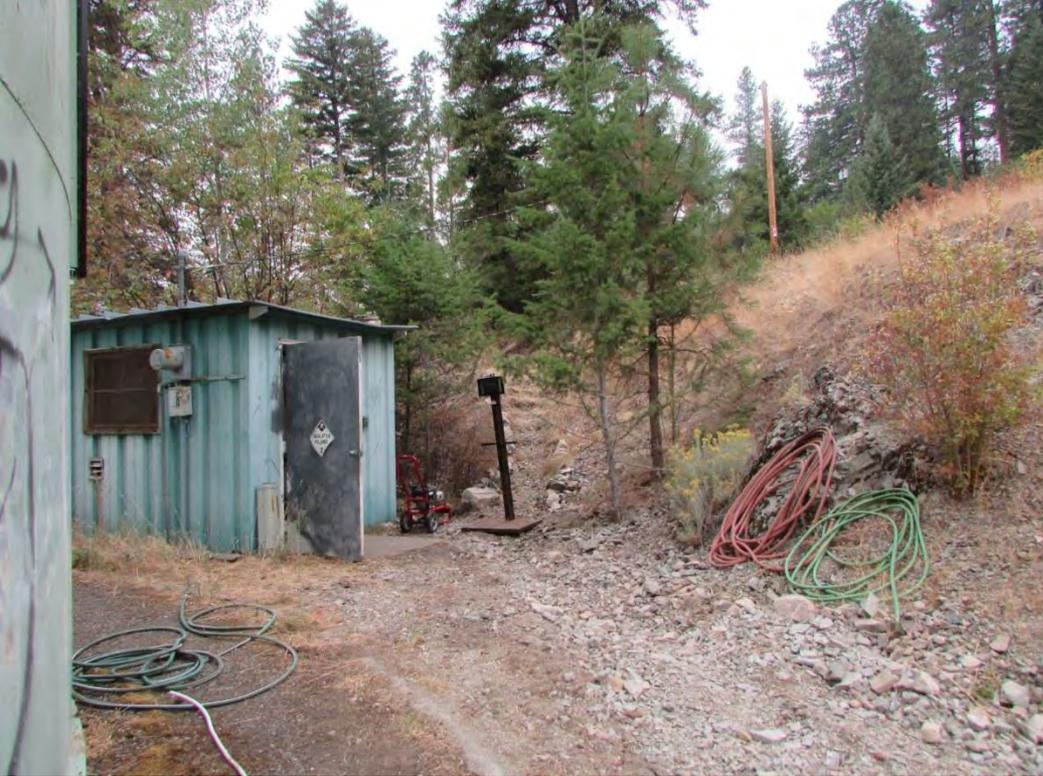
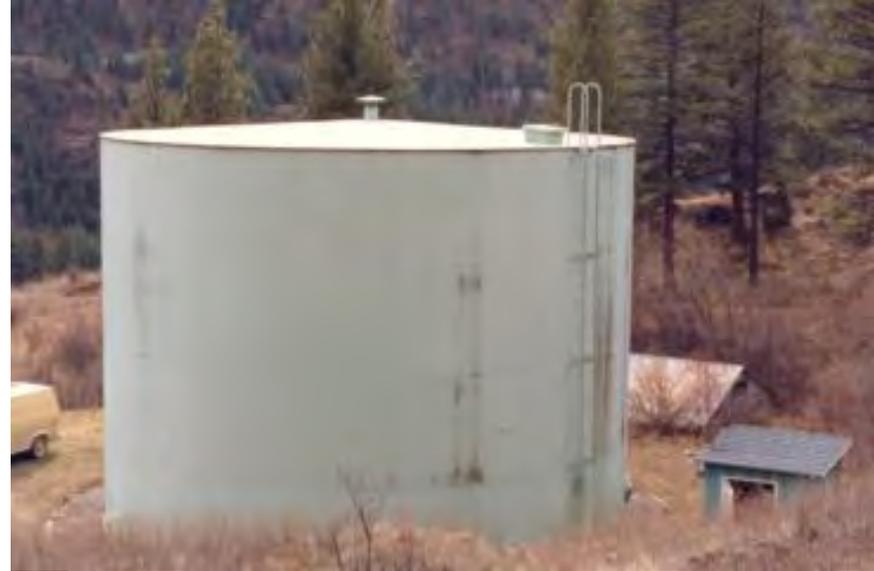
TP002 above left;  
ST001 above right;  
ST001 overflow line below left;  
remote sensing set up for SP002, ST001, and TP002 access below right.

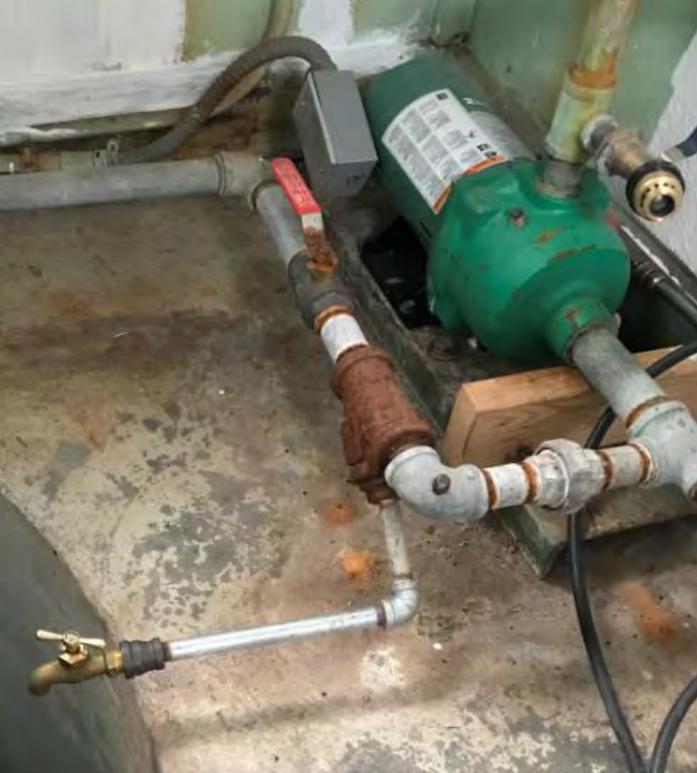
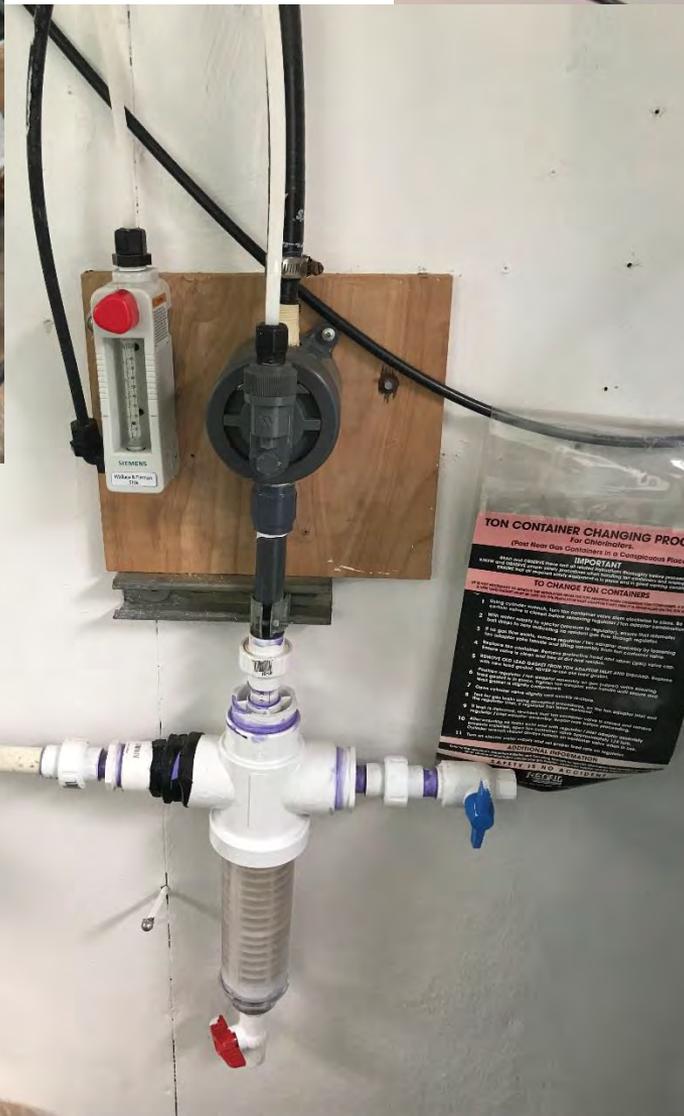
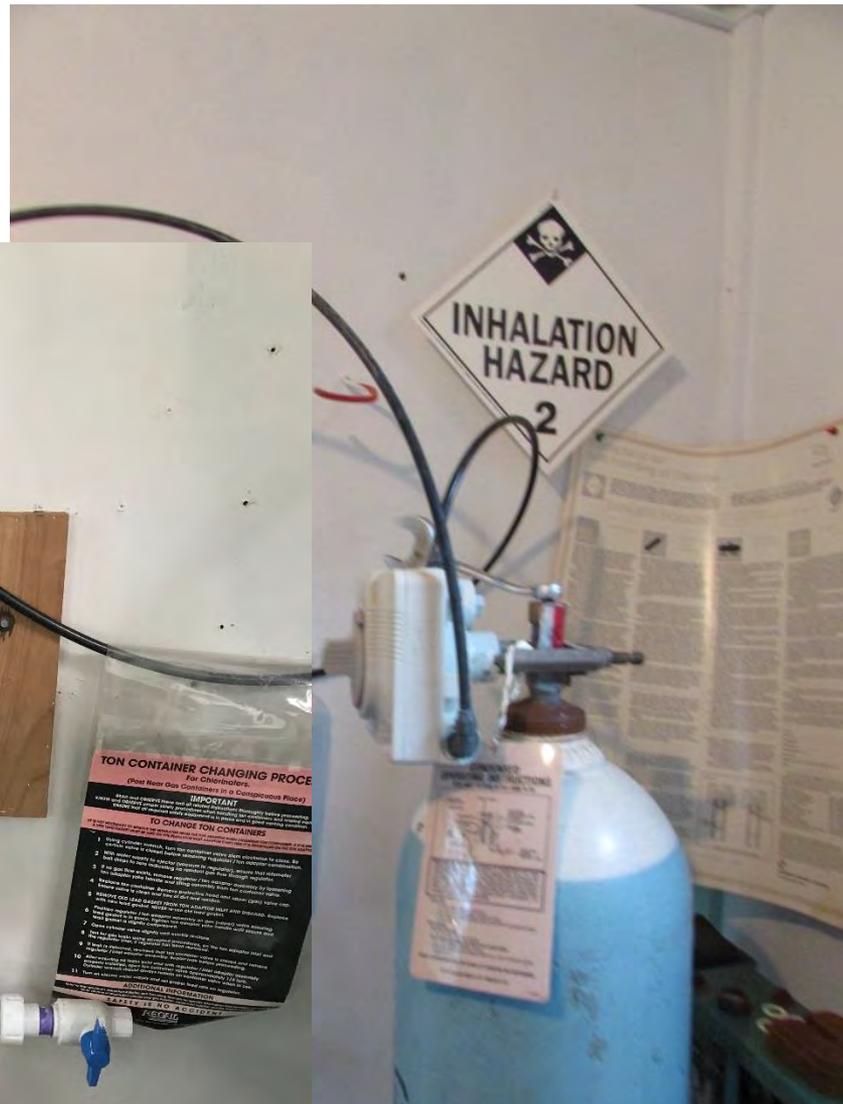
Above, relocated sample tap for collection of a raw source sample (RW002); middle, new centrifugal separator installed on the gaseous chlorine injector water supply line.

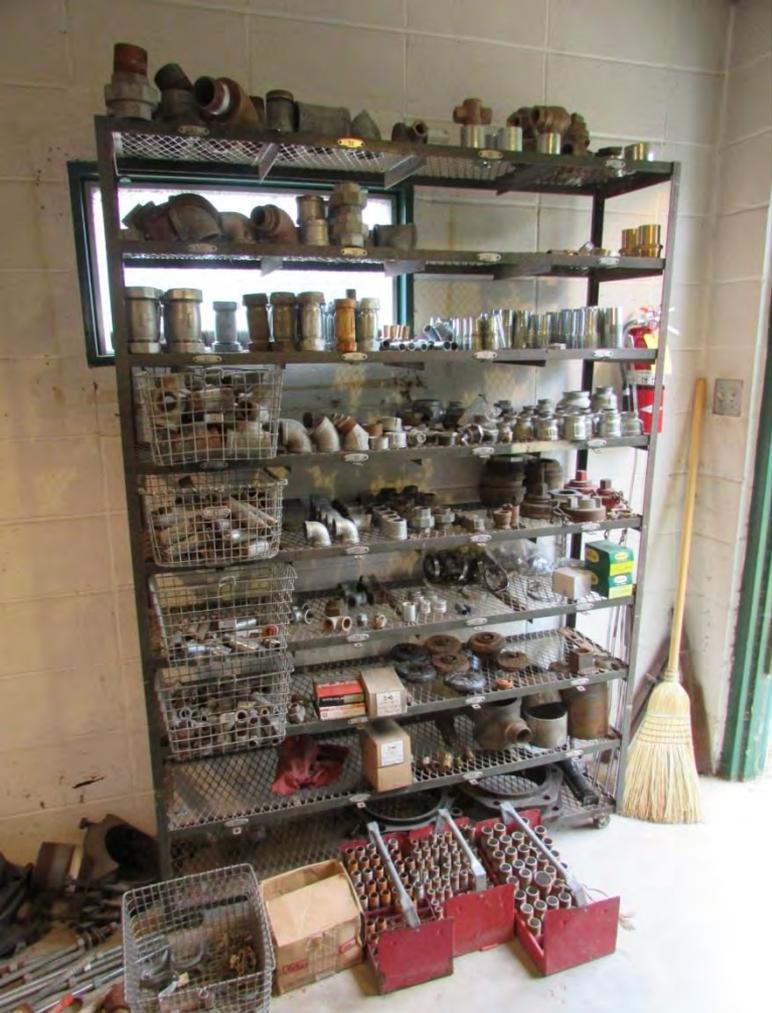
Above left, spare parts inventory on hand in the well house.

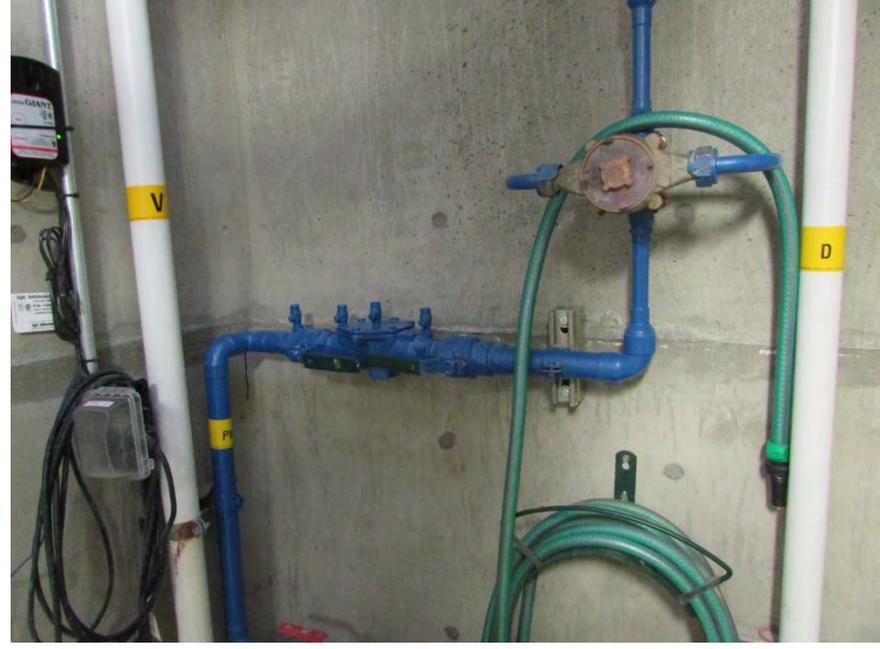
There is an RPZA in place at the wastewater treatment plant for cross connection protection, above right.

Be sure to have this device tested by a certified backflow device tester as required.

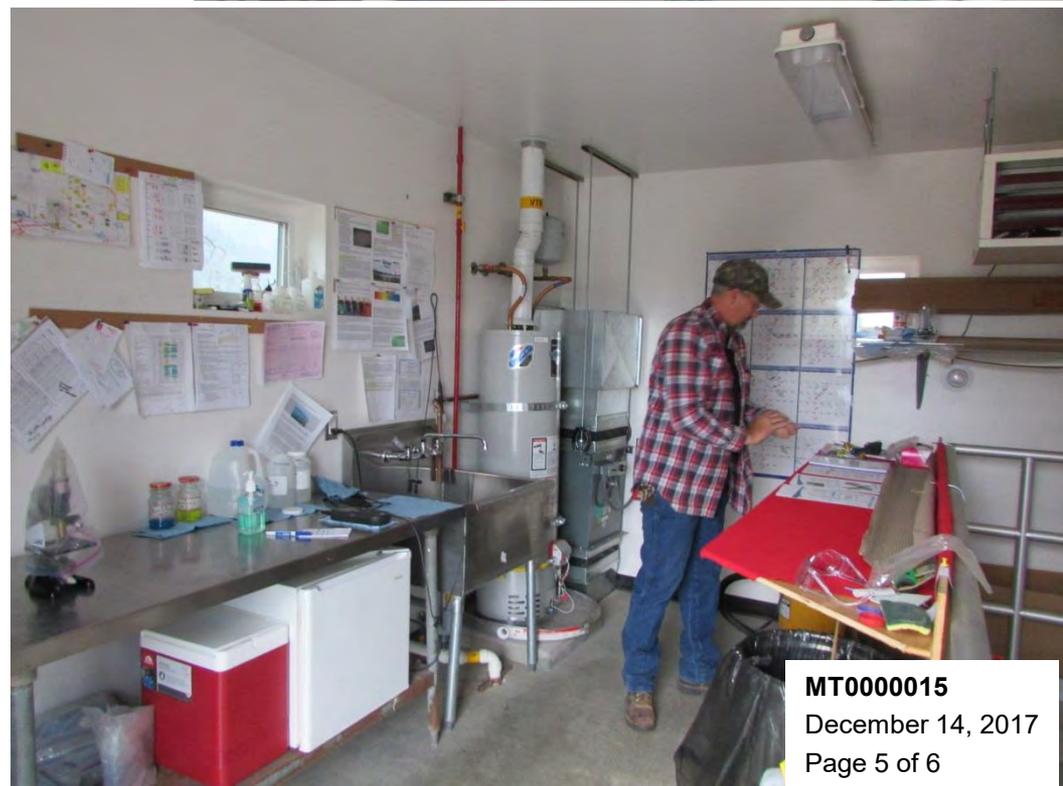
James has a laboratory space at the wastewater treatment plant. I encouraged him to use this lab for his PWS field chemistry also. He has posted important documents, drawings, and procedures he regularly uses.

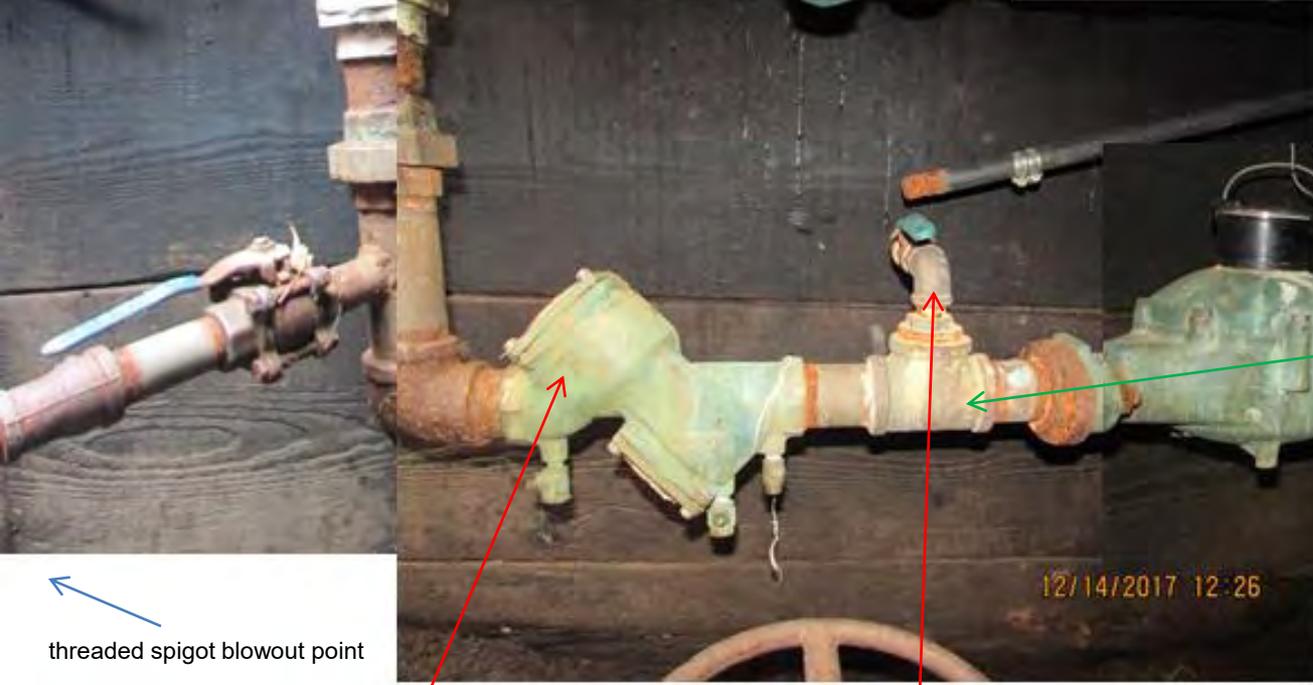
**VALVE VAULT SCHEMATIC**

← threaded spigot blowout point

SIGNIFICANT DEFICIENCY underground automatic irrigation supply line with NO bfpd or rpza in place.

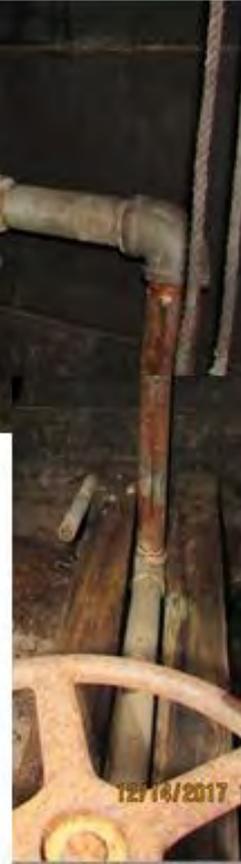
SIGNIFICANT DEFICIENCY incorrect/inadequate bfpd/rpza in place
